Manhole Inspection Summary

Manhole # S27A1_010MH

Location Address: **2132 ANNAPOLIS RD.**

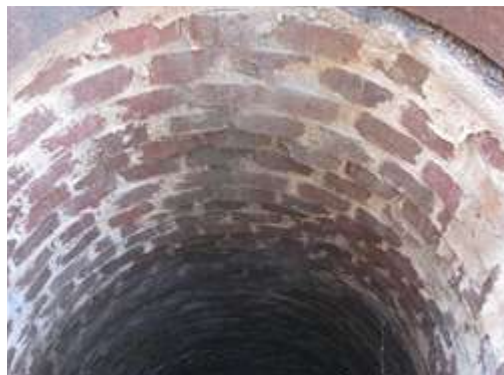
Defect 2

Infiltration: ☐ None ☐ Joint ☐ Cracks ☒ **Mortar** ☐ Roots ☐ Wall

signs of infiltration at corbel

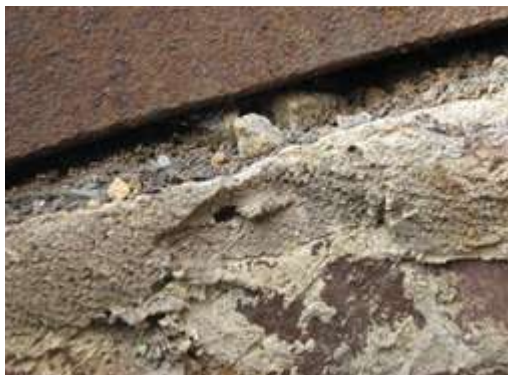
Defect 1

gap between frame and chimney

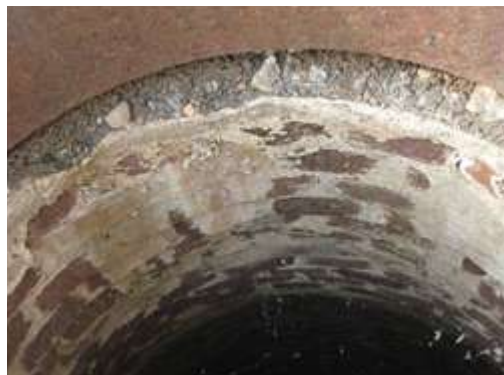
Defect 5

Offset: **1.** (in.)
25

Condition: ☐ Sound ☒ **Cracked** ☐ Root Intrusion ☐ Loose Brick ☒ **Deteriorated**

Infiltration: ☐ None ☒ **Joint** ☐ Cracks ☐ Mortar ☐ Roots ☒ **Wall**

Frame Offset, Chimney Deteriorated

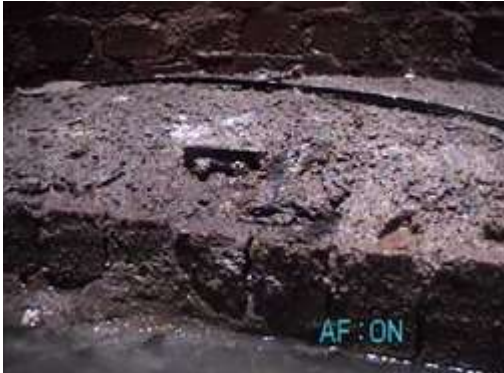
Defect 4

Condition: ☐ Sound ☐ Cracked ☐ Root Intrusion ☐ Deteriorated ☐ Leaks ☒ **Debris**

debris on bench

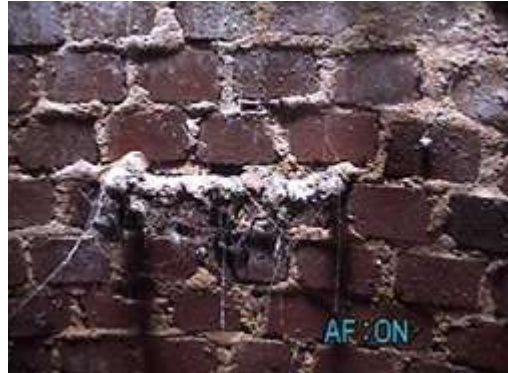
Defect 3

☒ **Evidence Of Surcharge** Depth: **4** (ft.) ☐ Active Surcharge Present

signs of surcharge

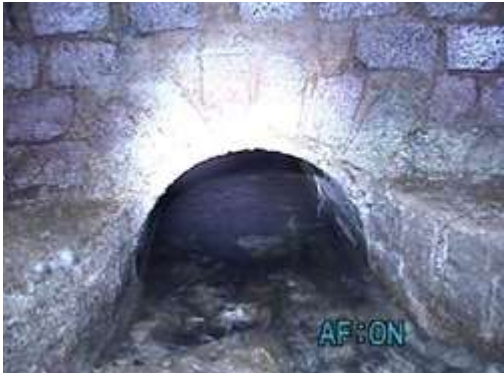
Defect 6

Condition: ☐ Sound ☐ Cracked ☐ Root Intrusion ☐ Deteriorated ☐ Leaks ☒ **Debris**

debris in channel

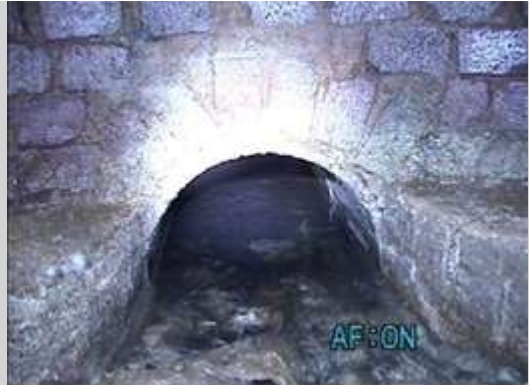
12 O'Clock Outflow

debris in channel

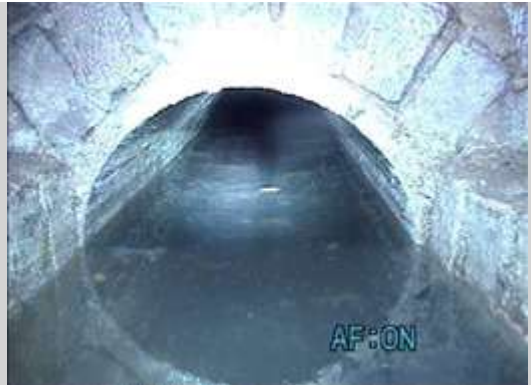
9 O'Clock Inflow

Deposits: ☐ None ☐ Mud ☒ **Sludge** ☐ Debris ☐ Grease

Silt Depth: **4** (in.) Deposits Extent: **Medium**
